ADDENDUM TO PLANNING AND ENGINEERING ASSESSMENT
CARRIAGE PARK AT BOUND BROOK

PREPARED FOR
MOUNTAIN REAL ESTATE GROUP

BLOCK 68 LOT 1.02
BOROUGH OF BOUND BROOK
SOMERSET COUNTY, NEW JERSEY

December 6, 2010

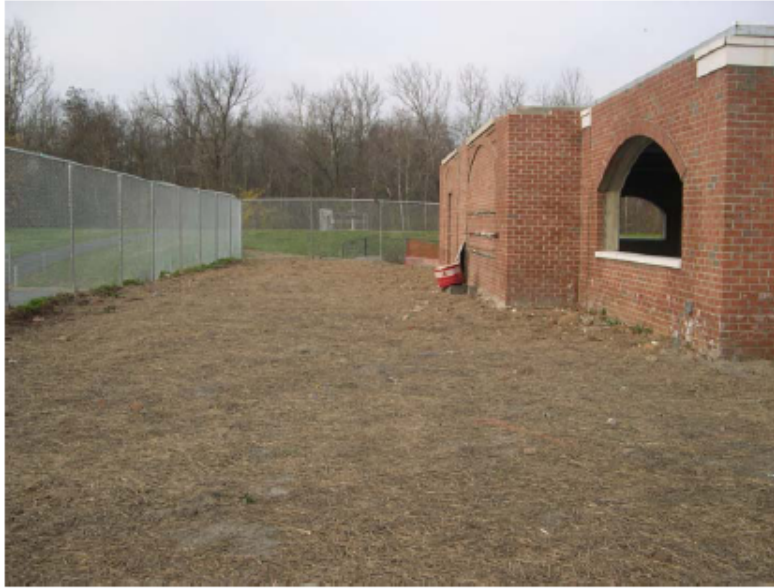
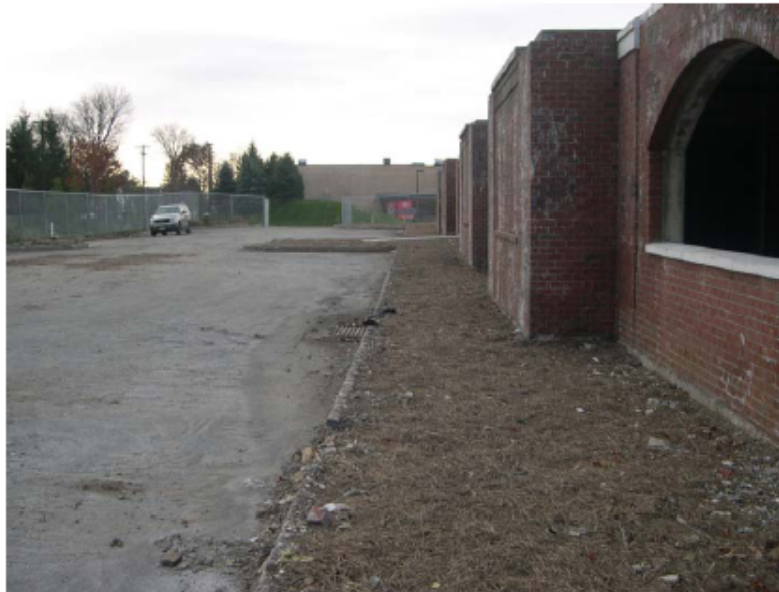
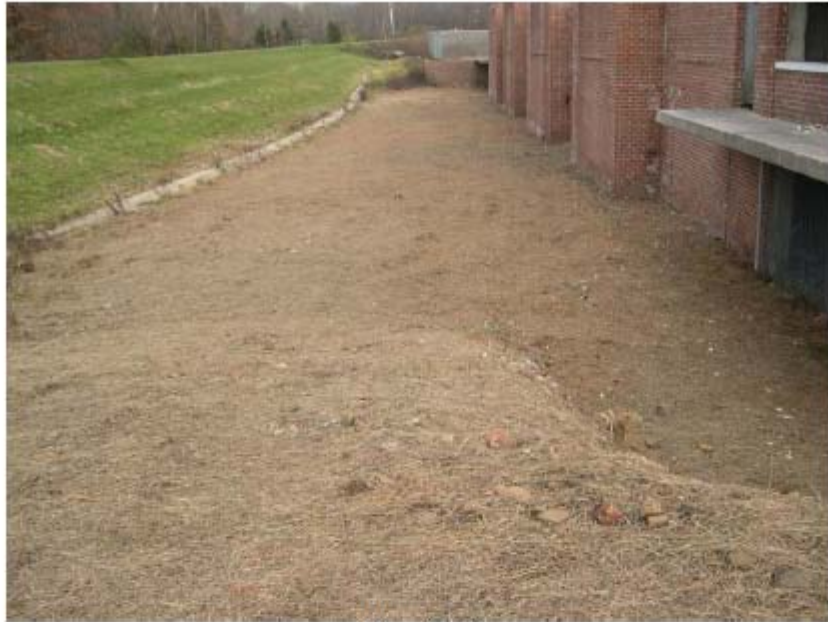
The soil areas that appear to have been disturbed as part of the building's demolition have been rough graded, seeded and hayed as part of a temporary site stabilization plan. This work has been done on what were the three finished sides of the building, the east, west and south side (see photos 1, 2 and 3). The north side of the building, which has the access to the garage parking area was only rough graded with no stabilization put in place(see photo 4).

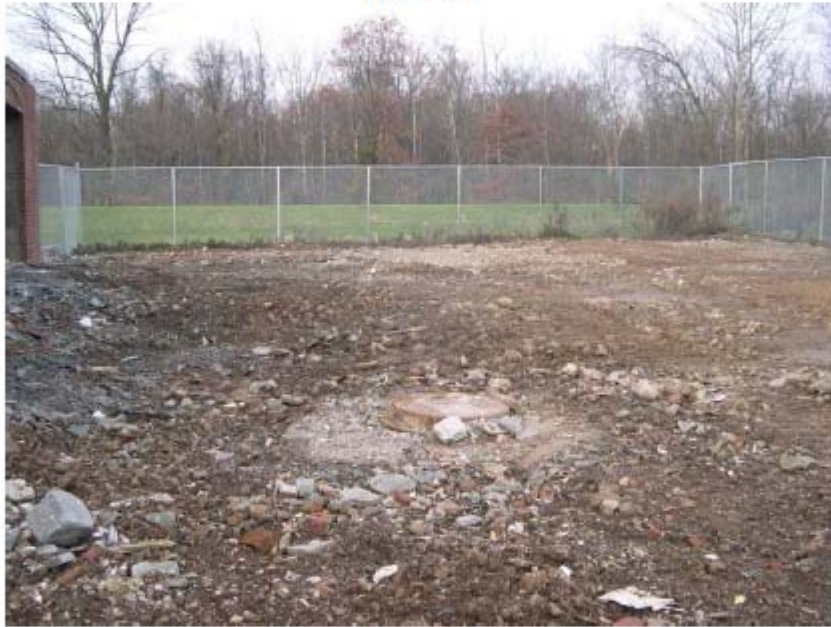
Photo No. 4

The rough graded area on the north side of the building (see photo 4) contains a layer of demolition debris that was left on the surface of the soil. This layer of debris will have to be removed prior to the start of any site work. The debris in this area extends outside of the fence enclosure to the pad for building # 2. It is assumed that this was the staging area for the final piling and removal of the demolition debris. This debris must be removed from the soil before any future site work is to take place in this area.

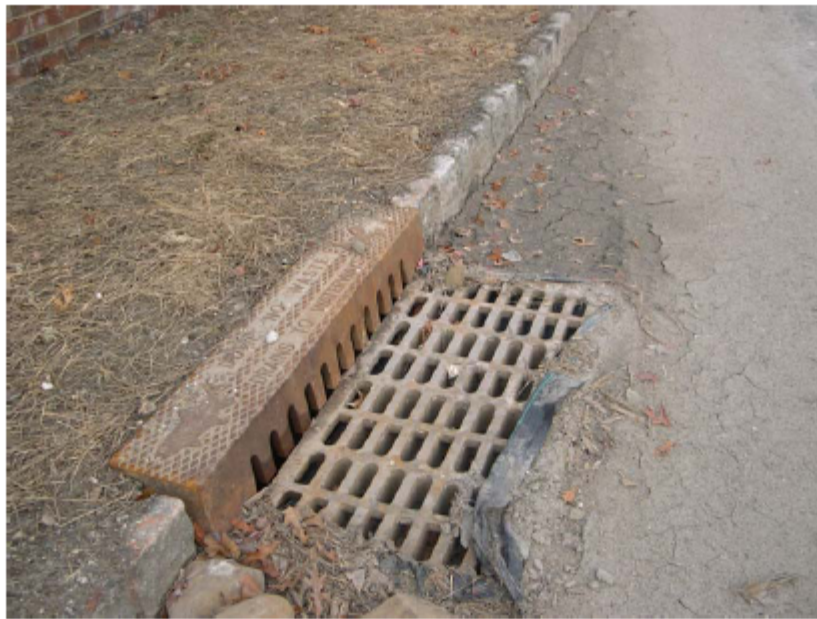
Photo No. 5

A review of the on-site stormwater management system shows that there is no major damage to the existing inlets within the parking lot on the east side of the building. The pavement and curb around the inlets appear to be in good condition (see photo 5). An internal inspection of the storm inlets was not possible as the filter fabric for erosion control was still in place. However given the condition of

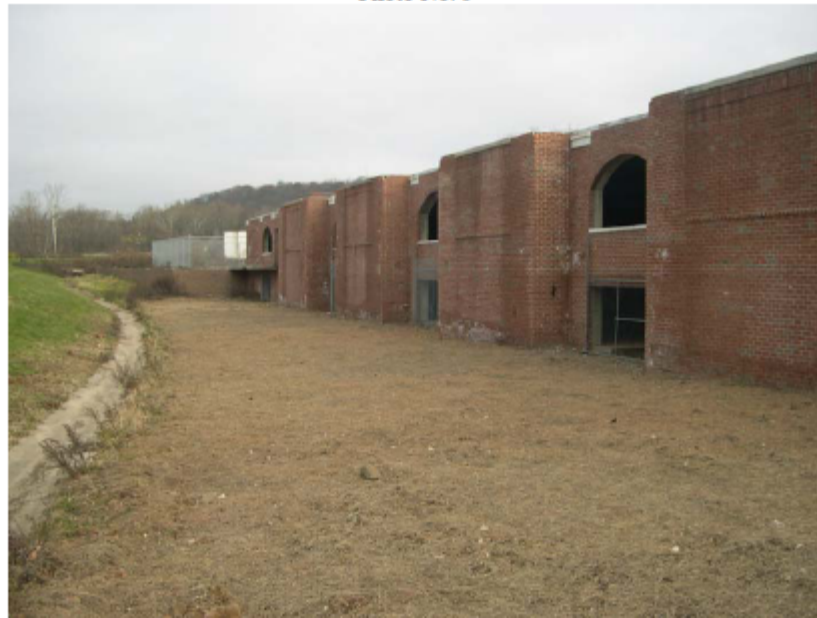
Photo No. 6

The impoundment area on the west side of the building appears to have been re-graded after demolition work was completed (see photo 6). A closer inspection of this area reveals that remnants of demolition debris have been left within the top few inches of the soil. The grade in this area has also been altered slightly and it appears that the minimum two percent pitch has not been maintained from the building edge to the concrete low flow channel. It is recommended that the demolition debris within the top six inches of soil be removed, the area re-graded from the building to the low flow channel and re-stabilized so as to provide the minimum two percent pitch.

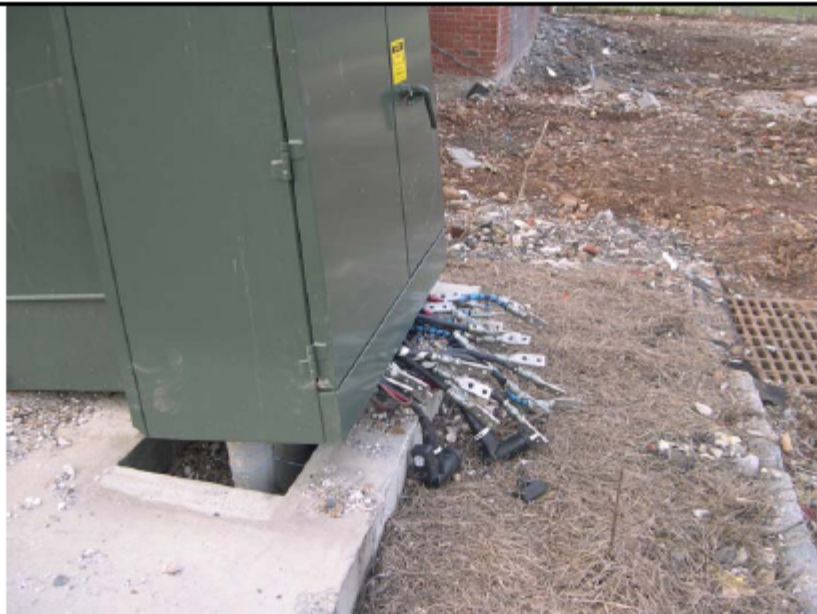
Photo No. 7

These utilities consist of electric, gas, telephone and cable service for the development. An inspection of the site shows that the electric service was disconnected from both the utility pole and at the transformer (see photo 7). The transformer was lifted off of its base and the wires pulled out from underneath. This has caused the transformer to tilt and it is unclear if any damage has occurred to the transformer or the internal connections. It is recommended that the transformer be inspected by a licensed electrician to determine if any damage has occurred before it can be considered for service.

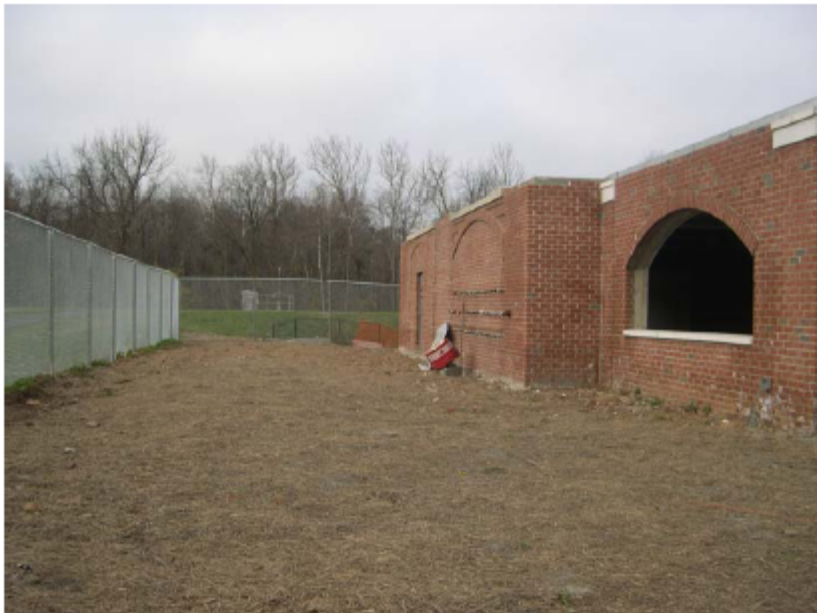
Photo No. 8

The gas service was disconnected from the building (see photo 8), the main supply line has been covered over with a metal drum and all meters that were on the building have been removed. Since the gas company owns the service line from the main to the building, it is recommended that they be contacted to inspect the condition of the gas line under the metal drum to ensure that the gas is turned off and the line is in proper working order.

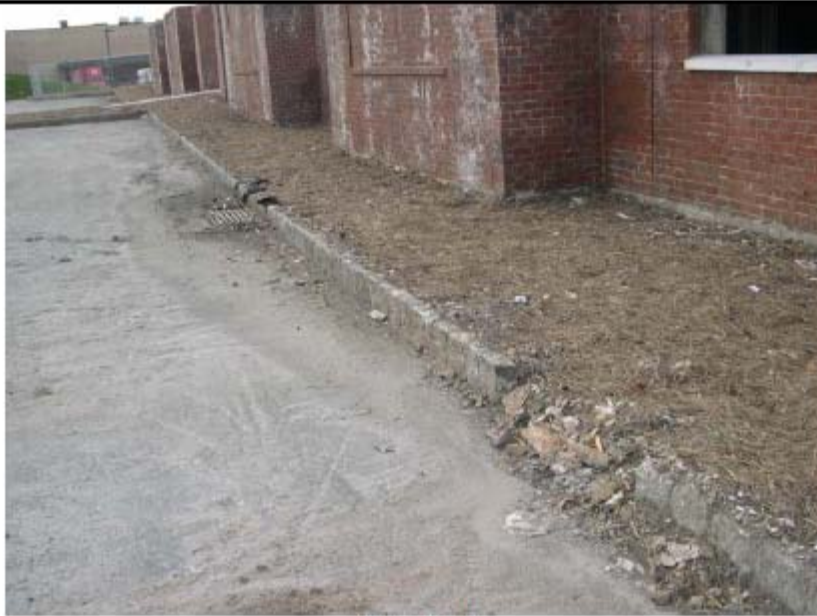
Photo No. 9

An inspection of the hardscape around the building revealed a few minor areas where repairs will be required. The existing pavement will need to be cleaned of sediment build up that has occurred around the low points adjacent to the inlets (see photo 9). The remaining pavement areas appear to have not sustained any major damage and are still subject to the comments contained within the Planning and Engineering Assessment Report.

The existing curb has sustained some damage along the front of the building (see photo's 9, 10 and 11). The curb in these areas will have to be replaced at the commencement of site work. The main entrance sidewalk into the building has also sustained some minor damage and will have to be replaced prior to certificate of occupancy.

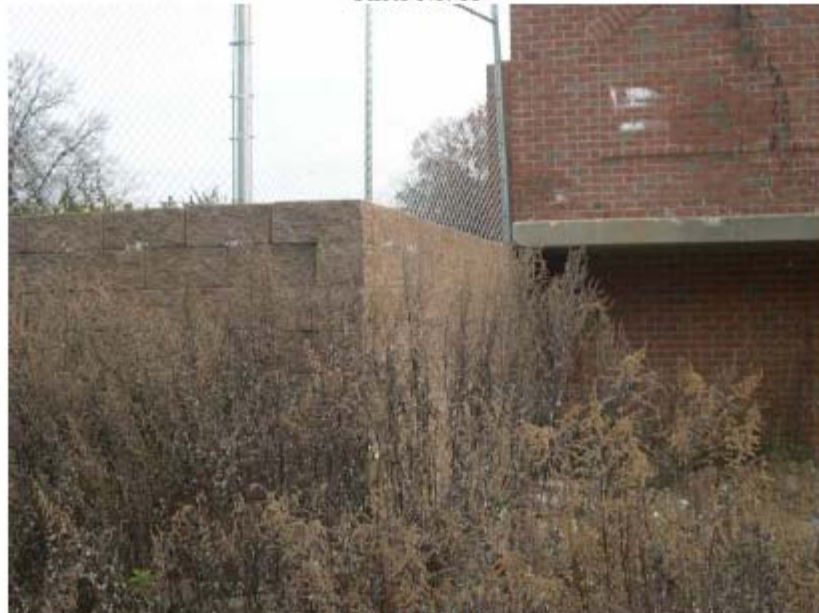
Photo No. 12

There is an existing retaining wall which connects into the corner of the building (see photo 12). The wall appears to be in the same condition as reported in the Planning and Engineering Assessment Report and any repairs outlined in that report should be addressed at the restart of construction.

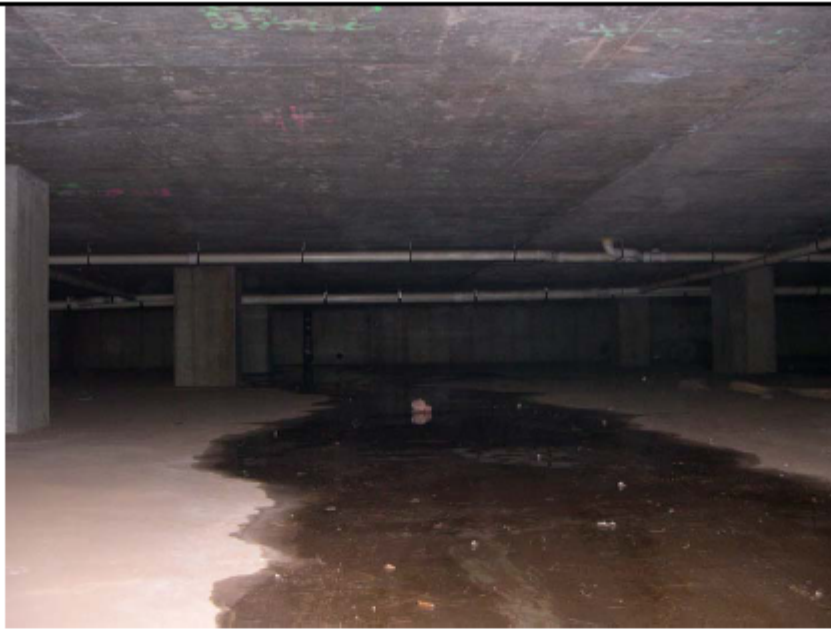
Photo No. 13

A review of the under-building storm water storage area reveals that it appears to be in proper working condition with no visual damage evident (see photo 13).
